CHAPTER

15

Trailer Service and Inspection

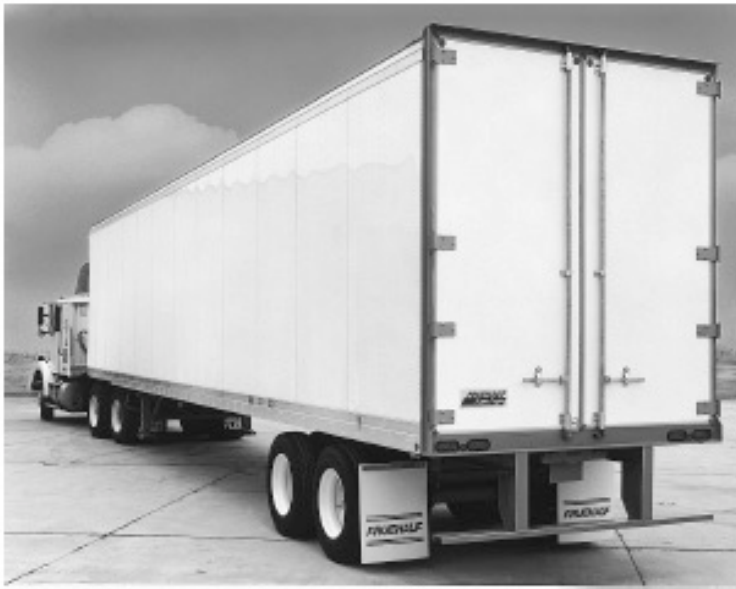
**A**

Swing Doors

- Leaks in van trailers may be found by a light test, water test, smoke test, or ultrasonic test.
- FRP plywood is multiple layers of matt fiberglass cloth bonded to both sides of a plywood core, providing excellent strength and corrosion resistance.
- The two types of doors used on van-type trailers are hinged and roll-up.

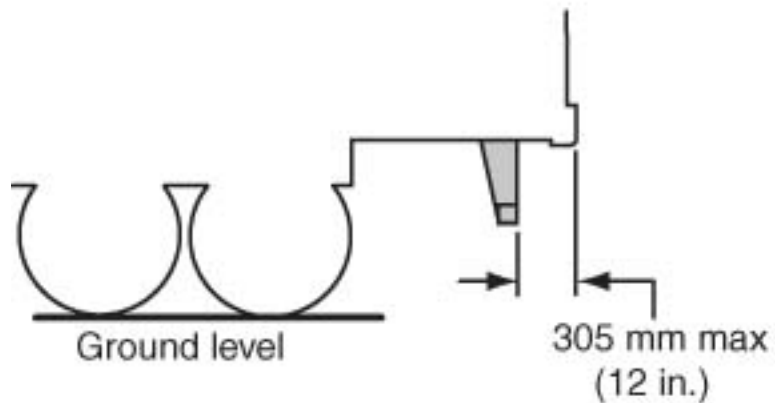
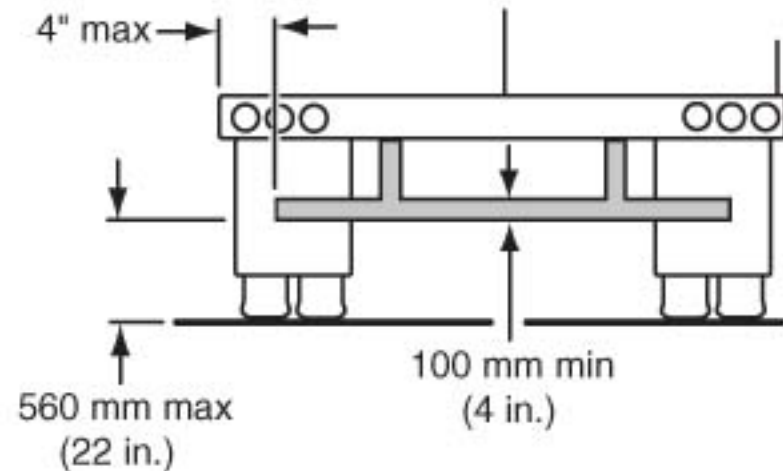
Underride Dimensions

NOTE: All dimensions are for unloaded trailers on a flat surface.

- The trailer's floor system should be inspected on every PMI to ensure it can safely handle the loads it is intended to support and ensure its service life.
- New floorboards must be supported by four crossmembers.
- Rear impact guard, or underride guard, should be inspected regularly for cracked welds, cracked or fractured vertical members, cuts and tears in any member, and for dimensional conformity.

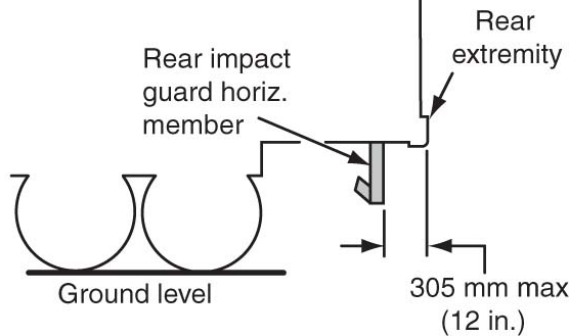
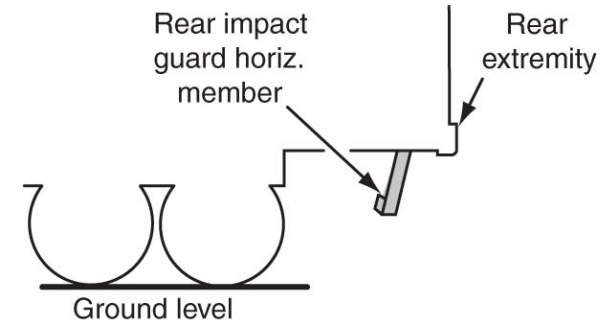
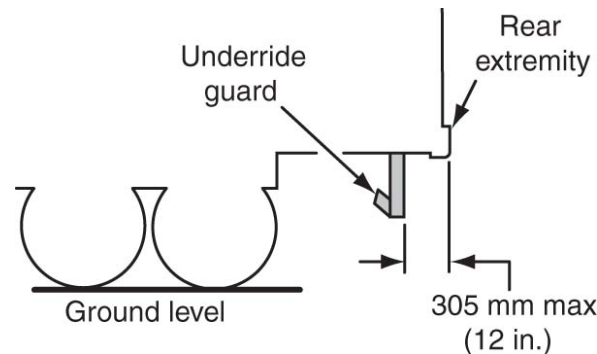
Under Guard Bends

If bent forward less than 3 inches, repair is not needed as long as it meets dimensions given.
